June 19, 2015
Subject: Back Pressure Relief Feature

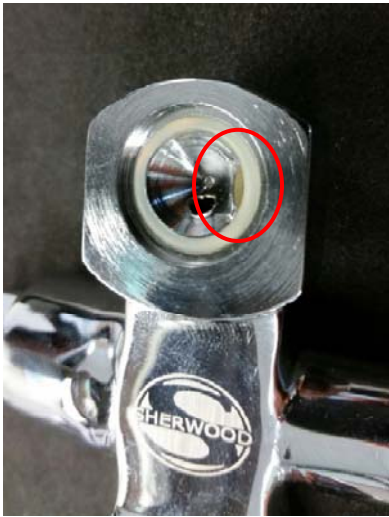
Sherwood K-Valve

Sherwood valves feature an intentional stamping mark in the machined inner ring of the o-ring gland. This mark prevents the metal ring from sealing against the 1st Stage regulator and trapping pressurized gas in the o-ring groove. If this gas is not properly vented, it can force the o-ring to dislodge when the 1st stage is removed from the valve. The stamping mark creates a path to vent any trapped gas before the 1st stage is removed.

In course of using a scuba valve, there are times where excess air may have accumulated behind the face o-ring during normal use. When this air is not vented properly from the o-ring groove it can cause the o-ring to dislodge during regulator dismounting.
